**Flood Control Project Maintenance
Levee Inspections**
LMA District Cover Sheet
Spring 2017 Levee Inspection Results

Reclamation District No. 0070 Meridian

Spring 2017 Levee Inspection Results

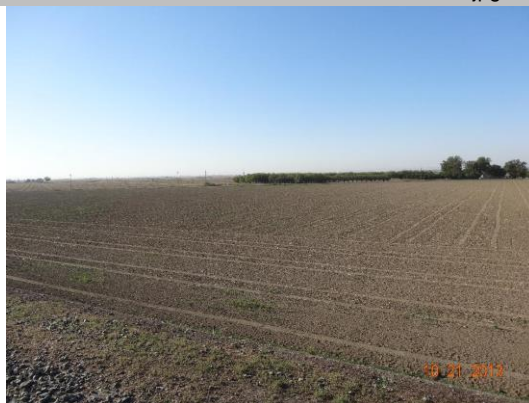
Photo 2 of 3 : UCIP_SP_2017_23463_40621.jpg

View of landward side where gas line markers are visible approximately 900 feet from levee.

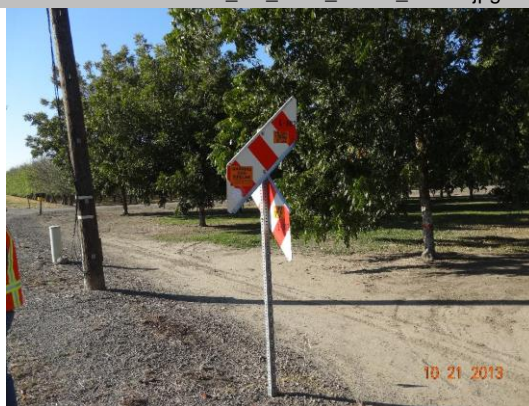
Photo 2 of 3 : UCIP_SP_2017_23384_40247.jpg

LM Start	0.55	Rating **	M	Issue No.	39 (cont)	
LM End	0.55	Issue Type +	En	Location *	WS	
Category	Supplemental			GPS Latitude/Longitude		
				Start		End
Item	DWR UCIP Field Study			39.142565 °	39.142565 °	
				-121.841600 °	-121.841600 °	
DWR ID						
Comment Code						
Inspector Comment						
FS_ID:23384						
DS_ID:21415						
EP_NO: 15936						
Repair Type: Non-Urgent						
Crossing Status: Indicator Found						
UCIP Comments: No markers visible on levee slope or levee toe to indicate line crosses levee. Need to contact PG&E to confirm location through levee. Also need to confirm the emergency contact person for this crossing.						
FIELD_STRUCT_DESC: 8-inch steel pipe through the levee, 2.5 feet below the crown. Gas line markers on the landward side. (Permit No. 15936-2005)						
FS Date: 10/21/2013

View of markers on the west side of S. Tarke Road.

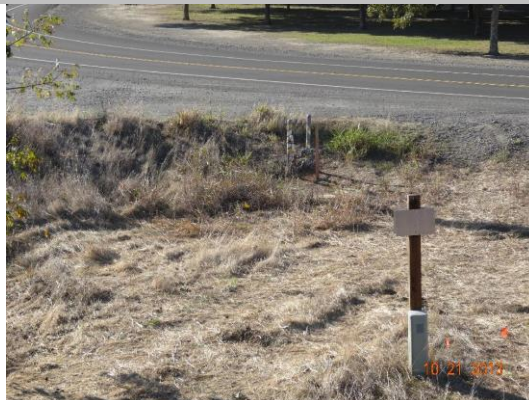
Photo 2 of 3 : UCIP_SP_2017_23467_40641.jpg

Additional appurtenances for gas line located at landward side near S. Tarke Rd.

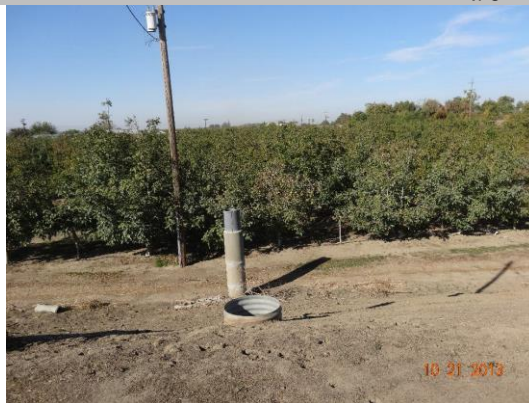
Photo 2 of 3 : UCIP_SP_2017_23526_40941.jpg

Comment Code					
Inspector Comment					
FS_ID:23526 DS_ID:21355 EP_NO: 9961 Repair Type: Non-Urgent Crossing Status: Found UCIP Comments: Dense burrow activity present on both waterward side and landward side. Recommend addressing burrow activity at this location. Also recommend having owner clear vegetation blocking access along walkway. This crossing is referenced in the USACE Periodic Inspection as item USACE_CESPK_MRD1_2012_p_290. FIELD_STRUCT_DESC: 10-inch (not 12-inch as noted in desk study) steel pipe through the levee, 5.4 feet below the crown. Siphon breaker in CM pipe riser on landward slope. 24-inch concrete standpipe at landward toe. Walkway to pump on pile structure in stream. This pipe was retained under ABO No. 9961 (1974). FS Date: 10/21/2013

View of standpipe and CMP riser located on landward side.

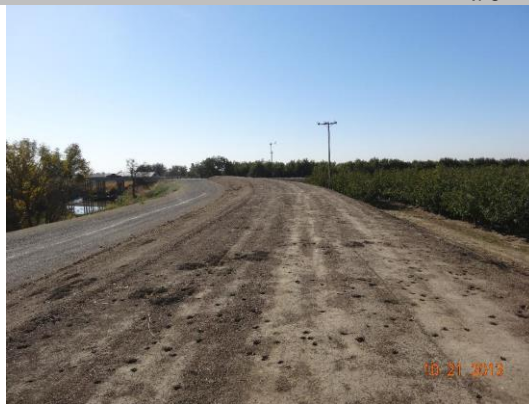
Photo 3 of 3 : UCIP_SP_2017_23526_40940.jpg

View of levee crown and waterward berm looking upstream from crossing.

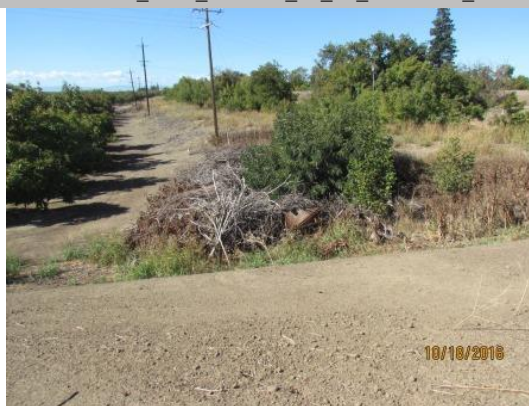
Photo 1 of 1 : SP_2017_RD0070_29_33_20170315_00008.jpg

LM Start	0.75	Rating **	M	Issue No.	33
LM End	0.75	Issue Type +	En	Location *	LS
Category	Earthen Levee			GPS Latitude/Longitude	
				Start	End
Item	Encroachments			39.145095 °	39.145095 °
				-121.842865 °	-121.842865 °
DWR ID	DWR_RD0070_01_f_2016_33				
Comment Code					
PR : Prunings					
Inspector Comment					
Remove the prunings from the landside slope.

View of the prunings along the landside toe.

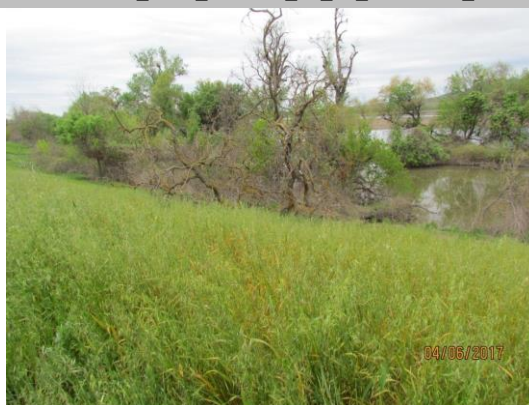
Photo 1 of 1 : SP_2017_RD0070_29_28_20170410_00063.jpg

LM Start	1.06	Rating **	M	Issue No.	28
LM End	1.06	Issue Type +	En	Location *	WS
Category	Earthen Levee			GPS Latitude/Longitude	
				Start	End
Item	Encroachments			39.145325 °	39.145325 °
				-121.846988 °	-121.846988 °
DWR ID	DWR_RD0070_01_s_2017_28				
Comment Code					
TR : Tree or limb					
Inspector Comment					
Remove the tree from the waterside slope and toe.

View of the tree along the waterside slope and toe.

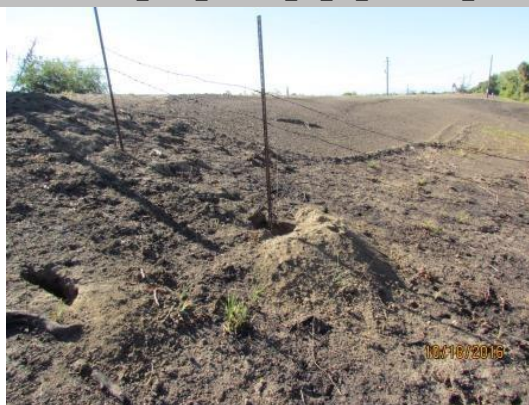
Photo 1 of 1 : SP_2017_RD0070_29_32_20170315_00007.jpg

LM Start	1.77	Rating **	M	Issue No.	32
LM End	1.77	Issue Type +	Ma	Location *	LS
Category	Earthen Levee			GPS Latitude/Longitude	
				Start	End
Item	Animal Control			39.151282 °	39.151282 °
				-121.855818 °	-121.855818 °
DWR ID	DWR_RD0070_01_f_2016_32				
Comment Code					
A1 : Exterminate rodents and backfill and compact or grout burrows.					
Inspector Comment

View of the rodent holes along the waterside slope.

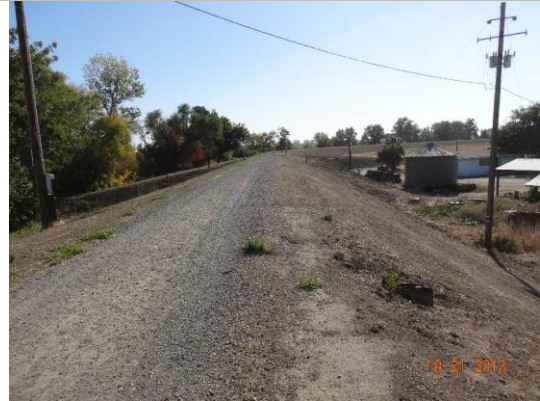
Photo 1 of 3 : UCIP_SP_2017_23508_40821.jpg

FS_ID:23508
DS_ID:21336
EP_NO: N/A
Repair Type: Non-Urgent
Crossing Status: Found
UCIP Comments: Need to find owner to determine if crossing is still in use. If crossing is no longer in use owner will need to coordinate with DWR inspector and CVFPB to remove according to Title 23 requirements. Evidence of high burrow activity on waterward side recommend addressing issue. This crossing is referenced as USACE_CESPK_MRD1_2012_p_0230 in the USACE's PI report for no USACE recommendation letter available -- correction pipe is 12-inch not 16-inch.
FIELD_STRUCT_DESC: 12-inch pipe through the levee, 4.0 feet below the crown. Siphon breaker on the landward slope. Concrete distribution box (7 ft by 9 ft) at landward toe. Service pole on waterward slope. Pump on concrete sump on waterward slope. Overhead power line crosses levee at location. This pipe was retained under ABO No. 9948 (1974) issued to Edward E. and Doris M. Nall. Permit No. 613 issued in May 29, 1934 is for 12 inch pipe issued to Waldo Nall.

View of levee crown looking upstream from crossing.

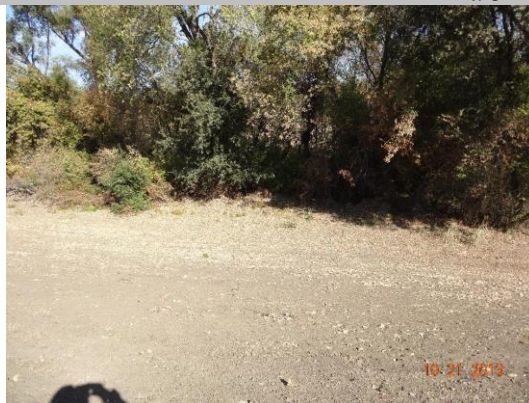
Photo 1 of 3 : UCIP_SP_2017_23530_40968.jpg

FS_ID:23530
DS_ID:21322
EP_NO: N/A
Repair Type: Non-Urgent
Crossing Status: Indicator Found
UCIP Comments: Unable to determine if crossing exists need to coordinate with LMA to determine if more information is available about crossing. This crossing is referenced in the USACE Periodic Inspection as item USACE_CESPK_MRD1_2012_p_0208 for concrete ditch lined within 15 feet of LS toe, no water present, and no USACE recommendation letter available.
FIELD_STRUCT_DESC: 12-inch steel pipe through the levee. Cutoff wall around pipe at center of levee. Two slide gates, on each end of pipe. Pump on waterward side. Concrete distribution box on landward side. (USACE-1953). This entry matches the Drainage or Irrigation Structure referenced in O&M manual (Station 142+70).
FS Date: 10/21/2013

View of waterward side.

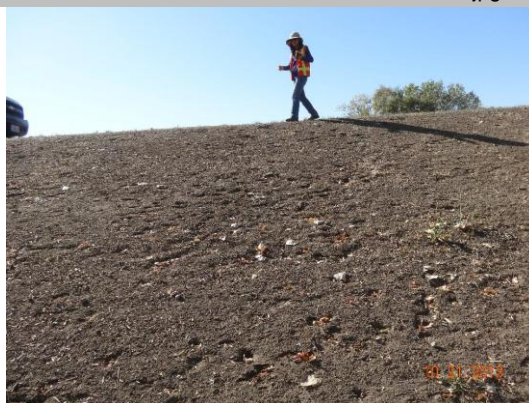
Photo 2 of 3 : UCIP_SP_2017_23530_40972.jpg

View of waterward slope.

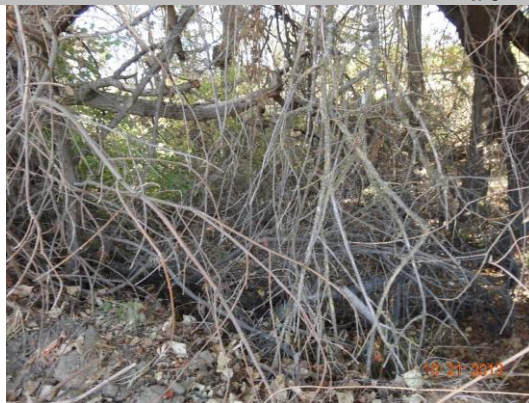
Photo 3 of 3 : UCIP_SP_2017_23530_40971.jpg

Comment Code						
Inspector Comment						
FS_ID:23530 DS_ID:21322 EP_NO: N/A Repair Type: Non-Urgent Crossing Status: Indicator Found UCIP Comments: Unable to determine if crossing exists need to coordinate with LMA to determine if more information is available about crossing. This crossing is referenced in the USACE Periodic Inspection as item USACE_CESPK_MRD1_2012_p_0208 for concrete ditch lined within 15 feet of LS toe, no water present, and no USACE recommendation letter available. FIELD_STRUCT_DESC: 12-inch steel pipe through the levee. Cutoff wall around pipe at center of levee. Two slide gates, on each end of pipe. Pump on waterward side. Concrete distribution box on landward side. (USACE-1953). This entry matches the Drainage or Irrigation Structure referenced in O&M manual (Station 142+70). FS Date: 10/21/2013

Waterward side covered by vegetation.

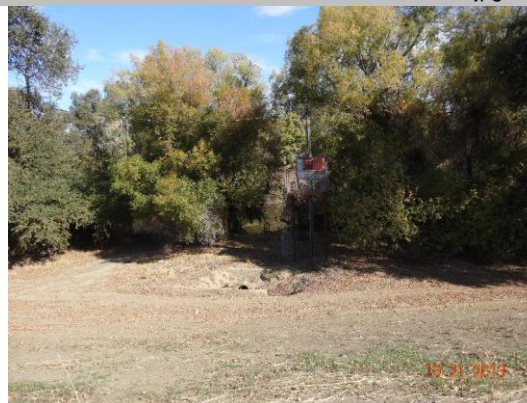
Photo 2 of 3 : UCIP_SP_2017_23510_40838.jpg

View of waterward side.

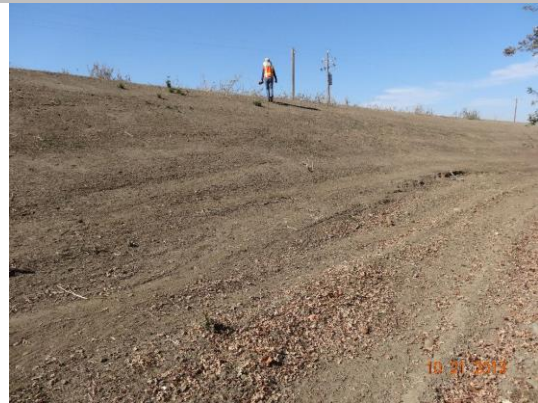
Photo 1 of 3 : UCIP_SP_2017_23515_40867.jpg

FS_ID:23515
DS_ID:21364
EP_NO: 9954
Repair Type: Non-Urgent
Crossing Status: Found
UCIP Comments: Power pole down on waterward side. Need to coordinate with owner to determine status of crossing. If crossing is no longer in use owner will need to contact the CVFPB to comply with Title 23. This crossing is referenced in the USACE Periodic Inspection as item USACE_CESPK_MRD1_2012_p_0147.
FIELD_STRUCT_DESC: 18-inch (not 24-inch as listed in desk study) steel pipe through the levee, 18.0 feet below the crown. Pipe crosses levee at a 45 degree angle. Slide gate in concrete box (5x5 foot) at waterward toe. Pump in pump house on the waterward side--no pump house found on waterward side. Discharge box at the landward toe. Power pole at the waterward toe. This pipe was retained under ABO No. 9954 (1974).
FS Date: 10/21/2013

View of waterward slope.

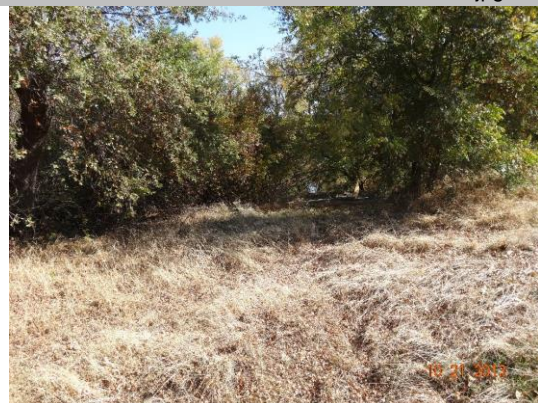
Photo 2 of 3 : UCIP_SP_2017_23515_40868.jpg

View of waterward side.

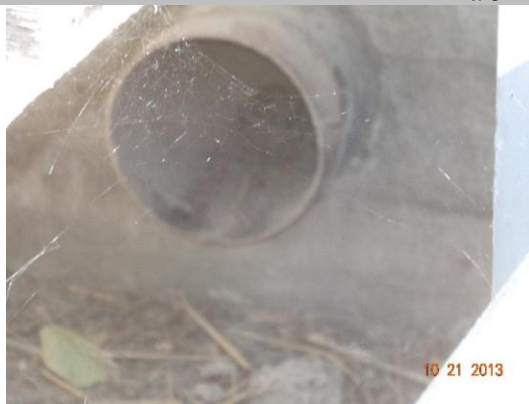
Photo 2 of 3 : UCIP_SP_2017_23516_40872.jpg

View of pipe on landward side inside concrete distribution box.

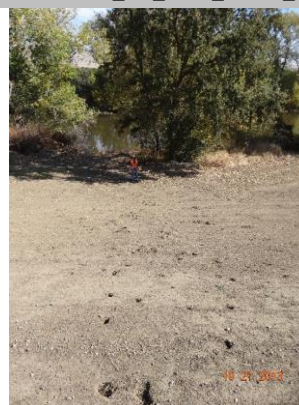
Photo 1 of 3 : UCIP_SP_2017_23517_40883.jpg

Comment Code					
Inspector Comment					
FS_ID:23517					
DS_ID:21340					
EP_NO: 9954					
Repair Type: Non-Urgent					
Crossing Status: Found					
UCIP Comments: Burrow activity present on waterward slope. Need to coordinate with owner to determine status of crossing. If crossing is no longer in use owner will need to contact the CVFPB to comply with Title 23. This crossing is referenced in the USACE Periodic Inspection as item USACE_CESPK_MRD1_2012_p_0134.					
FIELD_STRUCT_DESC: 24-inch CM pipe through the levee, 19.0 feet below the crown. Slide gate on the waterward. Concrete distribution box at landward toe. This pipe was retained under ABO No. 9954 (1974).					
FS Date: 10/21/2013

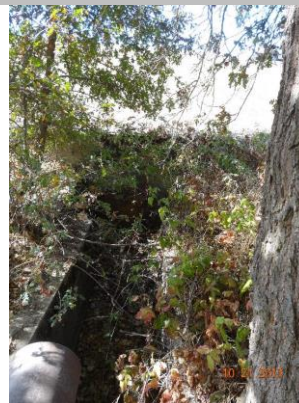
Photo 2 of 3 : UCIP_SP_2017_23517_40877.jpg

Comment Code						
Inspector Comment						
FS_ID:23517						
DS_ID:21340						
EP_NO: 9954						
Repair Type: Non-Urgent						
Crossing Status: Found						
UCIP Comments: Burrow activity present on waterward slope. Need to coordinate with owner to determine status of crossing. If crossing is no longer in use owner will need to contact the CVFPB to comply with Title 23. This crossing is referenced in the USACE Periodic Inspection as item USACE_CESPK_MRD1_2012_p_0134.						
FIELD_STRUCT_DESC: 24-inch CM pipe through the levee, 19.0 feet below the crown. Slide gate on the waterward. Concrete distribution box at landward toe. This pipe was retained under ABO No. 9954 (1974).						
FS Date: 10/21/2013

View of pipe located on waterward side.

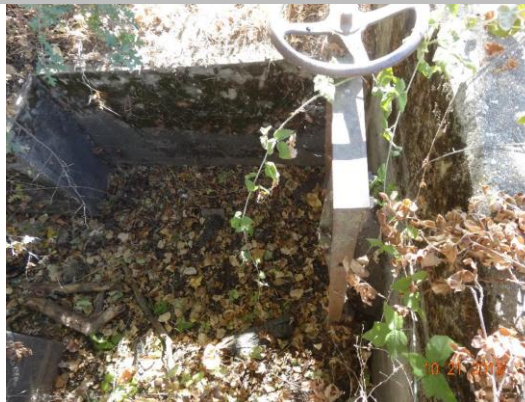
Photo 3 of 3 : UCIP_SP_2017_23517_40882.jpg

View of slide gate on waterward side.

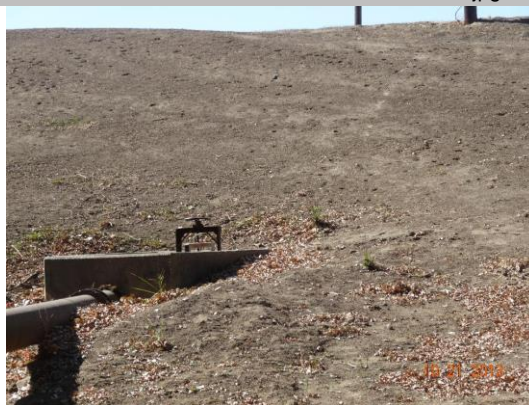
Photo 2 of 3 : UCIP_SP_2017_23518_40887.jpg

FS_ID:23518
DS_ID:21338
EP_NO: 9940
Repair Type: Non-Urgent
Crossing Status: Found
UCIP Comments: No connection present--need to contact owner to determine if owner plans to use. If crossing is no longer in use owner will need to coordinate with DWR inspector and CVFPB to remove according to Title 23 requirements. Unable to determine if crossing is in use. This crossing is referenced in the USACE Periodic Inspection as item USACE_CESPK_MRD1_2012_p_0125.
FIELD_STRUCT_DESC: 18-inch steel pipe through the levee, 19.0 feet below the crown. Cutoff wall around pipe at center of levee. Slide gate in concrete distribution box on landward side. Pump on waterward side. Discharges into concrete box on the landward side. (USACE-1953). This entry matches the Drainage or Irrigation Structure referenced in O&M manual (Station 251+30). This pipe was retained under ABO No. 9940 (1974).
FS Date: 10/21/2013

View of waterward slope.

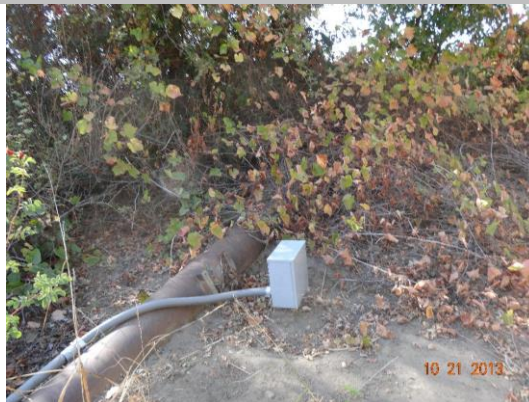
Photo 2 of 3 : UCIP_SP_2017_23519_40898.jpg

LM Start	5.41	Rating **	M	Issue No.	51
LM End	5.41	Issue Type +	En	Location *	LS
Category	Supplemental			GPS Latitude/Longitude	
				Start	End
Item	DWR UCIP Field Study			39.176780 °	39.176780 °
				-121.908025 °	-121.908025 °
DWR ID					
Comment Code					
Inspector Comment					
FS_ID:23519 DS_ID:21357 EP_NO: 9957 Repair Type: Non-Urgent Crossing Status: Found UCIP Comments: Burrow activity on slopes -- recommend addressing issue. This crossing is referenced in the USACE Periodic Inspection as item USACE_CESPK_MRD1_2012_p_0110. FIELD_STRUCT_DESC: 12-inch steel pipe through the levee, 5.5 feet below the crown. Siphon breaker in CM pipe riser on landward slope. Pump on waterward slope. Discharges into concrete box and service pole at landward toe. This pipe was retained under ABO No. 9957 (1975). FS Date: 10/21/2013

Pipe and electrical conduit exposed on levee berm.

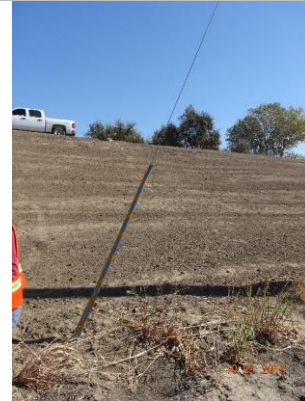
Photo 3 of 3 : UCIP_SP_2017_23519_40897.jpg

LM Start	5.41	Rating **	M	Issue No.	51 (cont)
LM End	5.41	Issue Type +	En	Location *	LS
Category	Supplemental			GPS Latitude/Longitude	
				Start	End
Item	DWR UCIP Field Study			39.176780 °	39.176780 °
				-121.908025 °	-121.908025 °
DWR ID					
Comment Code					
Inspector Comment					
FS_ID:23519					
DS_ID:21357					
EP_NO: 9957					
Repair Type: Non-Urgent					
Crossing Status: Found					
UCIP Comments: Burrow activity on slopes -- recommend addressing issue. This crossing is referenced in the USACE Periodic Inspection as item USACE_CESPK_MRD1_2012_p_0110.					
FIELD_STRUCT_DESC: 12-inch steel pipe through the levee, 5.5 feet below the crown. Siphon breaker in CM pipe riser on landward slope. Pump on waterward slope. Discharges into concrete box and service pole at landward toe. This pipe was retained under ABO No. 9957 (1975).					
FS Date: 10/21/2013

View of landward slope.

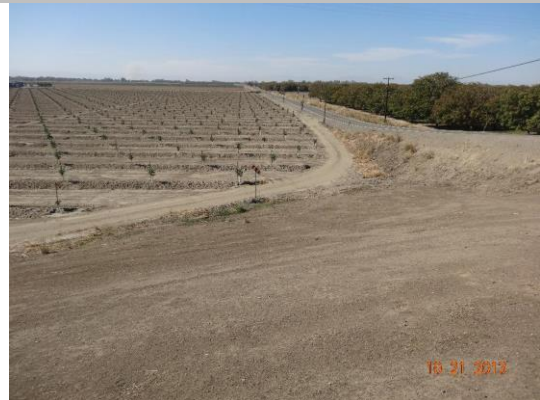
Photo 1 of 3 : UCIP_SP_2017_23479_40724.jpg

LM Start	6.12	Rating **	M	Issue No.	52
LM End	6.12	Issue Type +	En	Location *	LS
Category	Supplemental			GPS Latitude/Longitude	
				Start	End
Item	DWR UCIP Field Study			39.186652 °	39.186652 °
				-121.910549 °	-121.910549 °
DWR ID					
Comment Code					
Inspector Comment					
FS_ID:23479 DS_ID:21360 EP_NO: 4867 Repair Type: Non-Urgent Crossing Status: Found UCIP Comments: Utility marker contact information includes Contact prior to Excavation call 1-800-227-2600 or Emergency Contact 1-800-811-4111. Need to contact owner to determine status of crossing. Need date of last inspection and confirmation that crossing is still in operable condition. FIELD_STRUCT_DESC: 6.5-inch steel gas pipe through the levee, 4.0 feet below the crown. Concrete cutoff wall around pipe at center of levee. Rock revetment on waterward slope. (Permit No. 4867-1966) FS Date: 10/21/2013

View of landward side.

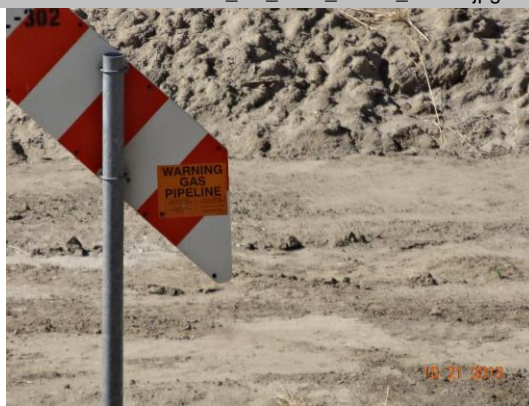
Photo 2 of 3 : UCIP_SP_2017_23479_40723.jpg

LM Start	6.12	Rating **	M	Issue No.	52 (cont)	
LM End	6.12	Issue Type +	En	Location *	LS	
Category	Supplemental			GPS Latitude/Longitude		
				Start		End
Item	DWR UCIP Field Study			39.186652 °		39.186652 °
				-121.910549 °		-121.910549 °
DWR ID						
Comment Code						
Inspector Comment						
FS_ID:23479 DS_ID:21360 EP_NO: 4867 Repair Type: Non-Urgent Crossing Status: Found UCIP Comments: Utility marker contact information includes Contact prior to Excavation call 1-800-227-2600 or Emergency Contact 1-800-811-4111. Need to contact owner to determine status of crossing. Need date of last inspection and confirmation that crossing is still in operable condition. FIELD_STRUCT_DESC: 6.5-inch steel gas pipe through the levee, 4.0 feet below the crown. Concrete cutoff wall around pipe at center of levee. Rock revetment on waterward slope. (Permit No. 4867-1966) FS Date: 10/21/2013

Pipeline marker on landward side.

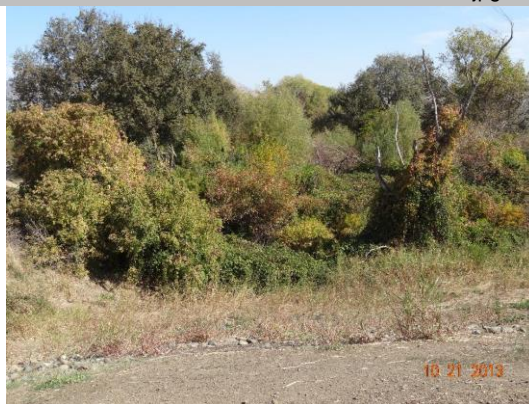
Photo 3 of 3 : UCIP_SP_2017_23479_40722.jpg

View of waterward side.

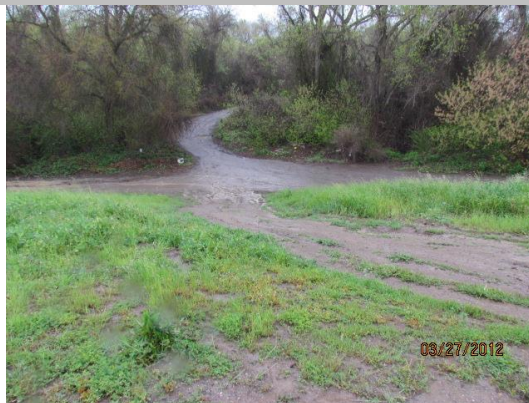
Photo 1 of 2 : SP_2017_RD0070_29_6_20170315_00001.jpg

LM Start	6.18	Rating **	M	Issue No.	6
LM End	6.18	Issue Type +	Ma	Location *	WS
Category	Earthen Levee			GPS Latitude/Longitude	
				Start	End
Item	Slope Stability			39.187481 °	39.187481 °
				-121.910852 °	-121.910852 °
DWR ID	DWR_RD0070_01_s_2012_6				
Comment Code					
S3 : Repair the levee slope damaged by vehicle traffic and prevent access where possible.					
Inspector Comment

View of vehicle erosion along the waterside slope.

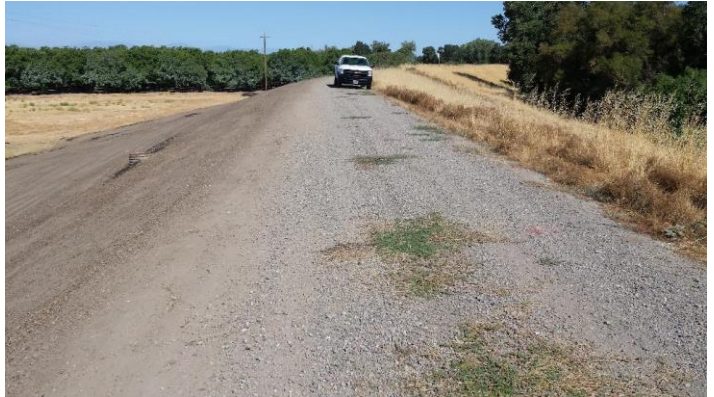
Photo 1 of 3 : UCIP_SP_2017_46422_74619.jpg

FS_ID:46422
DS_ID:21341
EP_NO: 9960
Repair Type: Non-Urgent
Crossing Status: Found
UCIP Comments: 07/28/2015 Pipe appears still appears abandoned. Priority was downgraded from Urgent to Non-Urgent due to the inactivity. Need to contact owner to confirm status and future use. If crossing is no longer in use owner will need to coordinate with DWR inspector and CVFPB to remove according to Title 23 requirements. 10/21/2013 Hole present on pipe on waterward side. This crossing was determined urgent due to hole on pipe-no signs leaks present on waterward or landward slopes. Unable to find if crossing is being used. Need to contact owner to determine crossing is still in use. If crossing is no longer in use owner will need to coordinate with DWR inspector and CVFPB to remove according to Title 23 requirements. Unable to determine if crossing is in use. This crossing is referenced in the USACE Periodic Inspection as item USACE_CESPK_MRD1_2012_p_0069.

Overview of levee crown at crossing. No change from last inspection.

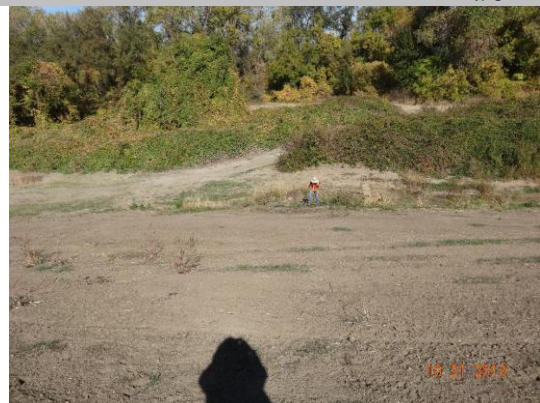
Photo 2 of 3 : UCIP_SP_2017_46422_40914.jpg

View of waterward side.

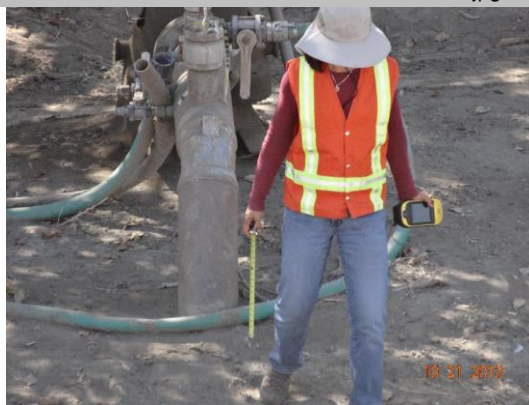
Photo 2 of 2 : UCIP_SP_2017_49188_40921.jpg

FS_ID:49188
DS_ID:21342
EP_NO: N/A
Repair Type: Non-Urgent
Crossing Status: Indicator Found
UCIP Comments: 06/21/2016 This crossing has been modified DWR levee log indicates 12-inch pipe not a 8-inch pipe, unable to determine if pipe goes through levee. This crossing appears to be an irrigation line. Need to find owner to clarify pipe use, determine whether pipe goes through levee, and determine the fate of the original 12-inch pipe through the levee. 10/21/2013 Unable to determine if this is an irrigation pipe or groundwater pipe. This crossing is referenced in the USACE Periodic Inspection as item
USACE_CESPK_MRD1_2012_p_0062--no permit available.
FIELD_STRUCT_DESC: 8-inch (not 12-inch as found in desk study) pipe through the levee. Pump and service pole at landward toe.
FS Date: 10/21/2013

Pump system and pipe on landward side.

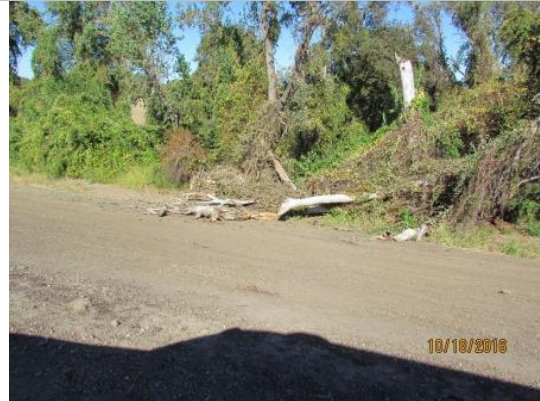
Photo 1 of 1 : SP_2017_RD0070_29_31_20170315_00006.jpg

LM Start	7.16	Rating **	M	Issue No.	31
LM End	7.16	Issue Type +	Ma	Location *	WS
Category	Earthen Levee			GPS Latitude/Longitude	
				Start	End
Item	Encroachments			39.196157 °	39.196157 °
				-121.922688 °	-121.922688 °
DWR ID	DWR_RD0070_01_f _ 2016_31				
Comment Code					
TR : Tree or limb					
Inspector Comment					
Remove the fallen tree.

View of a fallen tree along the waterside toe.

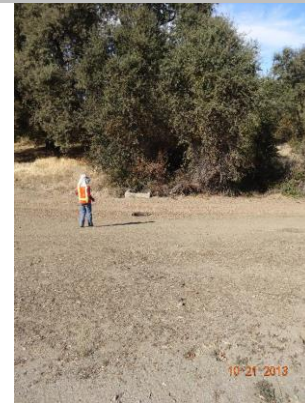
Photo 1 of 3 : UCIP_SP_2017_23529_40964.jpg

Comment Code					
Inspector Comment					
FS_ID:23529 DS_ID:21345 EP_NO: 9942 Repair Type: Non-Urgent Crossing Status: Found UCIP Comments: Dense vegetation limits the inspector's visibility to identify signs of pipe failure (leaks) along the slope. Recommend removing vegetation along pipe alignment to conduct proper inspection of structure and appurtenances. This crossing is referenced in the USACE Periodic Inspection as item USACE_CESPK_MRD1_2012_p_0005. FIELD_STRUCT_DESC: 24-inch CM pipe through the levee, 16.5 feet below the crown. Slide gate in CM pipe rise on waterward slope. Incline pump on waterward side. Discharges to concrete box at the landward toe. Service pole on landward side. (USACE-1953). This entry matches the Drainage or Irrigation Structure referenced in O&M manual (Station 330+00). This pipe was retained under ABO No. 9942 (1974). FS Date: 10/21/2013

View of waterward slope.

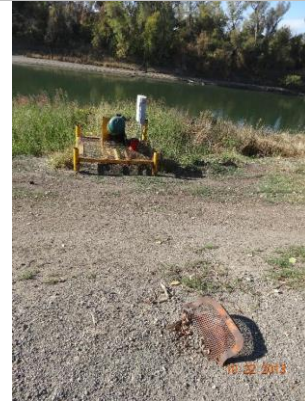
Photo 1 of 3 : UCIP_SP_2017_23952_42061.jpg

Comment Code					
Inspector Comment					
FS_ID:23952 DS_ID:21382 EP_NO: 12707 Repair Type: Non-Urgent Crossing Status: Found UCIP Comments: Burrow activity noticed at this location. Crossing appurtenances have been modified. No 36-inch concrete distribution stand pipe present instead there is a concrete distribution box located at the landward toe. Also siphon breaker housing unit damage. Will need to contact owner. Need to obtain maintenance records and clarify modifications made at to crossing. Recommend having owner clear vegetation on waterward side. This crossing is referenced in the USACE Periodic Inspection as item USACE_CESPK_MRD2_2012_p_0018. FIELD_STRUCT_DESC: 14-inch steel pipe through the levee, 3.0 feet below the crown. Steel cutoff wall around pipe at center of levee. Siphon breaker on apex of pipe at waterward shoulder. Pump on metal (not timber as noted in desk study) platform on waterward side. 36-inch concrete standpipe (not found during 10/2013 inspection) and service pole at landward toe. Rock revetment on waterward slope. (Permit No. 12707-1979) FS Date: 10/22/2013

View of waterward side--siphon breaker housing unit, pipe daylight, pump, and plateform.

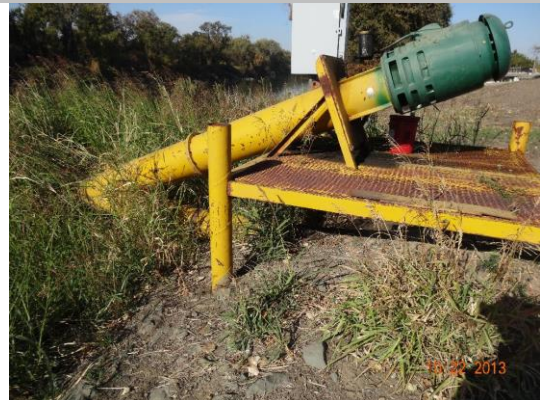
Photo 2 of 3 : UCIP_SP_2017_23952_42060.jpg

View of pump on waterward side.

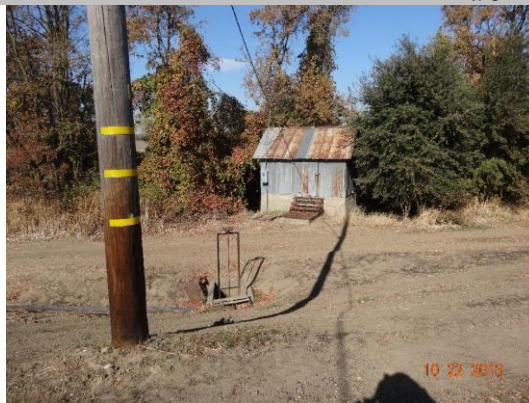
Photo 1 of 3 : UCIP_SP_2017_42923_42036.jpg

Comment Code					
Inspector Comment					
FS_ID:42923					
DS_ID:21412					
EP_NO: 1575					
Repair Type: Non-Urgent					
Crossing Status: Found					
UCIP Comments: Debris scattered on waterward side. Concrete structure on waterward side shows major cracks on the walls. Will need to notify owner. Need to obtain maintenance records to confirm integrity of pipe. This crossing is referenced in the USACE Periodic Inspection as item USACE_CESPK_MRD2_2012_p_0075.					
FIELD_STRUCT_DESC: 20-inch steel pipe through the levee, 17.0 feet below the crown. Pump in pump house and slide gate (10-inch) on waterward side. Concrete collar at waterward toe. Power pole on waterward slope, anchor on landward slope. Rock revetment on waterward slope. (Permit No. 1575-1959)					
FS Date: 10/23/2013

View of waterward side--appurtenances present pump house, concrete distribution box, screw gate, and power pole.

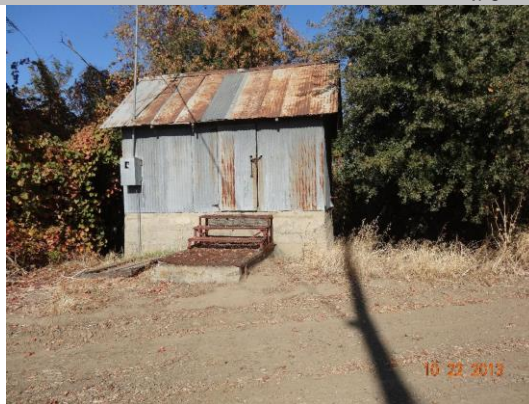
Photo 2 of 3 : UCIP_SP_2017_42923_42041.jpg

Pump station on waterward side.

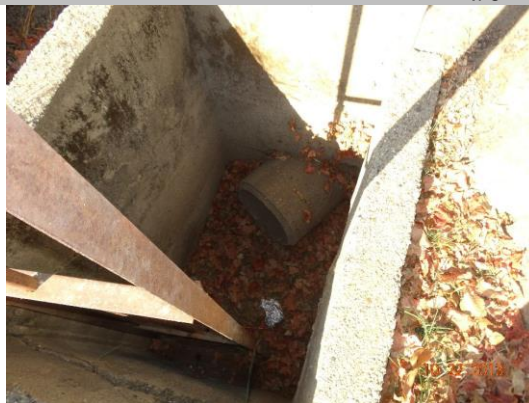
Photo 3 of 3 : UCIP_SP_2017_42923_42042.jpg

Comment Code						
Inspector Comment						
FS_ID:42923 DS_ID:21412 EP_NO: 1575 Repair Type: Non-Urgent Crossing Status: Found UCIP Comments: Debris scattered on waterward side. Concrete structure on waterward side shows major cracks on the walls. Will need to notify owner. Need to obtain maintenance records to confirm integrity of pipe. This crossing is referenced in the USACE Periodic Inspection as item USACE_CESPK_MRD2_2012_p_0075. FIELD_STRUCT_DESC: 20-inch steel pipe through the levee, 17.0 feet below the crown. Pump in pump house and slide gate (10-inch) on waterward side. Concrete collar at waterward toe. Power pole on waterward slope, anchor on landward slope. Rock revetment on waterward slope. (Permit No. 1575-1959) FS Date: 10/23/2013

Inside view of concrete distribution box located on waterward side.

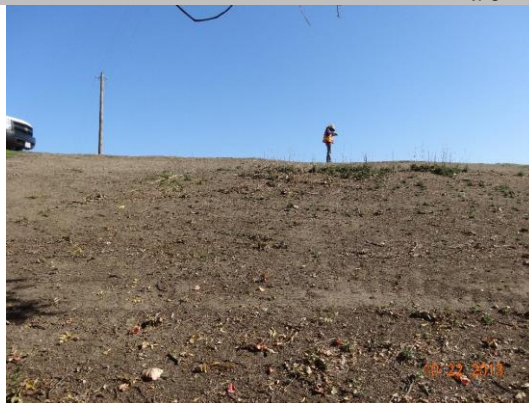
Photo 1 of 3 : UCIP_SP_2017_23885_41814.jpg

FS_ID:23885
DS_ID:21365
EP_NO: 9973
Repair Type: Non-Urgent
Crossing Status: Found
UCIP Comments: Cut to levee toe found on landward side. Unable to determine if crossing is being used. If crossing is no longer used by owner, the owner will need to coordinate with DWR Inspector and CVFPB to remove crossing according to Title 23 requirements. This crossing is referenced in the USACE Periodic Inspection as item USACE_CESPK_MRD2_2012_p_0099.
FIELD_STRUCT_DESC: 18-inch steel pipe through the levee, 18.8 feet below the crown. Slide gate on gate structure on waterward side. Slant pump on waterward side. (USACE-1953). This entry matches the Drainage or Irrigation Structure referenced in O&M manual (Station 399+34). This pipe was retained under ABO No. 9973 (1974).
FS Date: 10/22/2013

View of waterward slope.

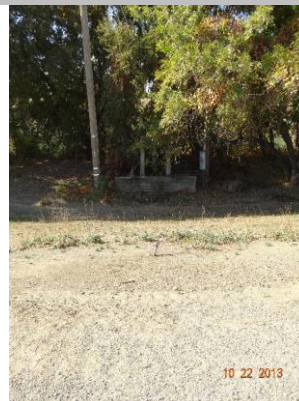
Photo 2 of 3 : UCIP_SP_2017_23885_41817.jpg

Overview of waterward slope.

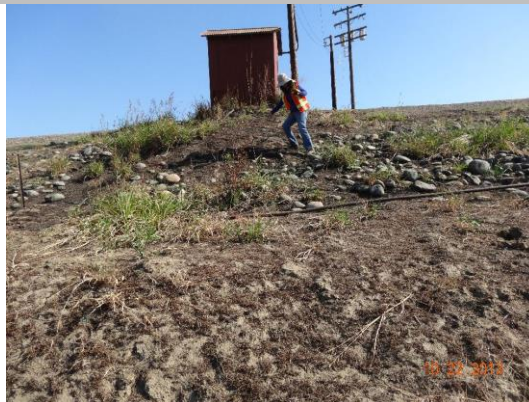
Photo 2 of 3 : UCIP_SP_2017_23888_41822.jpg

Comment Code					
Inspector Comment					
FS_ID:23888					
DS_ID:21366					
EP_NO: 9996					
Repair Type: Non-Urgent					
Crossing Status: Found					
UCIP Comments: Need inside photo of the concrete distribution box located at the landward toe. Debris found on waterward slope (conduit running parallel to levee). This crossing is referenced in the USACE Periodic Inspection as item USACE_CESPK_MRD2_2012_p_0124.					
FIELD_STRUCT_DESC: 12-inch steel pipe through the levee, 24.0 feet below the crown. Gate valve in concrete "U" headwall on waterward slope. Switch house and pump on waterward shoulder. Discharge box at landward toe. This pipe was retained under ABO No. 9996 (1974).					
FS Date: 10/22/2013

View of slope on waterward side.

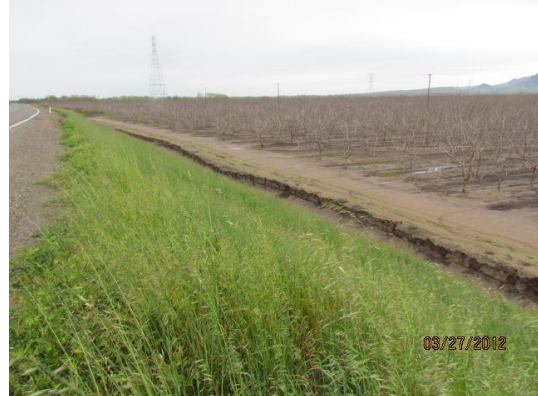
Photo 1 of 1 : SP_2017_RD0070_30_1_20170315_00001.jpg

LM Start	2.16	Rating **	M	Issue No.	1
LM End	2.32	Issue Type +	En	Location *	LS
Category	Earthen Levee			GPS Latitude/Longitude	
				Start	End
Item	Encroachments			39.168854 °	39.166503 °
				-121.936223 °	-121.935547 °
DWR ID	DWR_RD0070_02_s_2012_1				
Comment Code					
DT : Ditch					
Inspector Comment

Agricultural ditch along the landside toe.

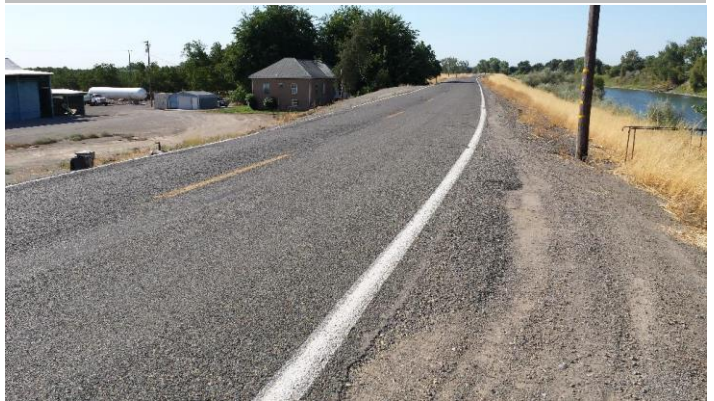
Photo 1 of 3 : UCIP_SP_2017_50006_74608.jpg

UCIP Comments: 7/07/2016 Pipe was running during site visit. Pipe has failed internally on both the WS and LS. The scour hole on LS toe has progress and it is now about 6-feet wide by 6-feet long by 5-feet deep. Hole on WS is not visible but water is leaking underneath pipe. It appears from last inspection that the leak on the WS has also progressed. This section of the levee is known as N. Meridian Road (County Road). According to LMA representative, Andy Duffey, owner plans on submitting application for repair. Company submitting application is Davis Machine Shop contact is Thomas Davis 530-696-2576. Property owner is Steven Tarke. LMA representative contact number is 1-530-696-2569 (office) or 1-530-682-2996 (cell). Permit No. 1158 issued in 1946 lists owner as Wayne Hall. (DWR UCIP - omagana)7/28/2015 Pipe was running during site visit. Scour hole located at landward side (LS) toe is still present. New signs of stress on slope are visible on LS near concrete box. On the waterward side (WS) 2 leaks are present. The first leak is located at the pipe joint near the WS toe, the joint connection is leaking significantly. The second potential leak is near the pipe daylight on WS. Unable to confirm cause of leak but downstream seepage is present along pipe alignment. Seepage indicates that pipe may be leaking and causing internal erosion and void along pipe alignment. Recommend LMA superintendent notify owner to stop using crossing to avoid further damage to levee. Owner will need to coordinate with DWR Inspector and CVFPB to address leaky pipe per Title 23 requirements. (DWR UCIP - omagana)

View of county road where pipe crosses.

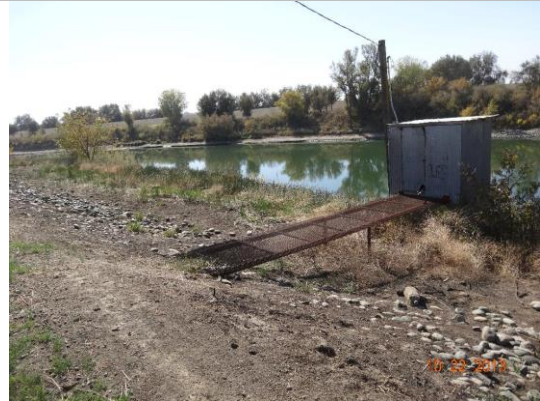
Photo 1 of 3 : UCIP_SP_2017_23891_41835.jpg

Comment Code					
Inspector Comment					
FS_ID:23891 DS_ID:21368 EP_NO: 9969 Repair Type: Non-Urgent Crossing Status: Found UCIP Comments: Landward slope too steep--need photo of the inside of concrete distribution box. Dense vegetation limits the inspector's visibility to identify signs of pipe failure (leaks) along the waterward slope. Recommend removing vegetation along pipe alignment to conduct proper inspection of structure and appurtenances. This crossing is referenced in the USACE Periodic Inspection as item USACE_CESPK_MRD2_2012_p_0158. FIELD_STRUCT_DESC: 20-inch (not 24-inch as mentioned in desk study) steel pipe through the levee, 27.0 feet below the crown. CM cutoff wall around pipe at center of levee. Pump and gate valve in pump house on the waterward slope. Discharges into concrete box at the landward toe. (USACE-1953). This entry matches the Drainage or Irrigation Structure referenced in O&M manual (Station 455+39). This pipe was retained under ABO No. 9969 (1974). FS Date: 10/22/2013

View of waterward side.

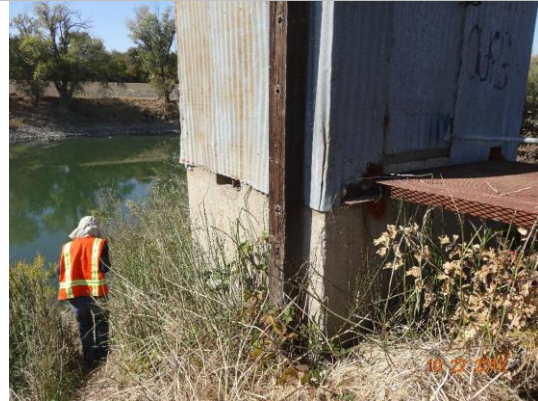
Photo 2 of 3 : UCIP_SP_2017_23891_41833.jpg

Comment Code						
Inspector Comment						
FS_ID:23891 DS_ID:21368 EP_NO: 9969 Repair Type: Non-Urgent Crossing Status: Found UCIP Comments: Landward slope too steep--need photo of the inside of concrete distribution box. Dense vegetation limits the inspector's visibility to identify signs of pipe failure (leaks) along the waterward slope. Recommend removing vegetation along pipe alignment to conduct proper inspection of structure and appurtenances. This crossing is referenced in the USACE Periodic Inspection as item USACE_CESPK_MRD2_2012_p_0158. FIELD_STRUCT_DESC: 20-inch (not 24-inch as mentioned in desk study) steel pipe through the levee, 27.0 feet below the crown. CM cutoff wall around pipe at center of levee. Pump and gate valve in pump house on the waterward slope. Discharges into concrete box at the landward toe. (USACE-1953). This entry matches the Drainage or Irrigation Structure referenced in O&M manual (Station 455+39). This pipe was retained under ABO No. 9969 (1974). FS Date: 10/22/2013

Pump station located on waterward side.

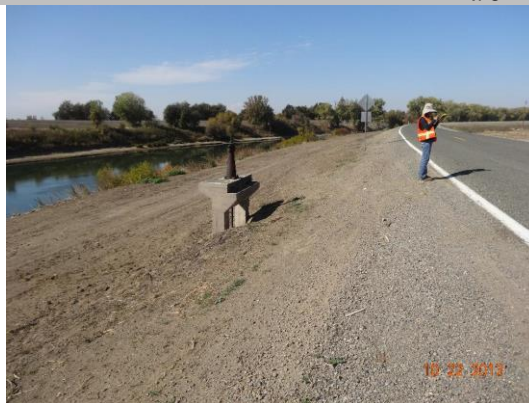
Photo 1 of 3 : UCIP_SP_2017_23892_41839.jpg

Comment Code					
Inspector Comment					
FS_ID:23892 DS_ID:21369 EP_NO: N/A Repair Type: Non-Urgent Crossing Status: Found UCIP Comments: If crossing is no longer used by owner, the owner will need to coordinate with DWR Inspector and CVFPB to remove crossing according to Title 23 requirements. Dense vegetation limits the inspector's visibility to identify signs of pipe failure (leaks) along the slope. Recommend removing vegetation along pipe alignment to conduct proper inspection of structure and appurtenances. This crossing is referenced in the USACE Periodic Inspection as item USACE_CESPK_MRD1_2012_p_0167. FIELD_STRUCT_DESC: *ABANDONED* 24-inch CM pipe through the levee, 21.0 feet below the crown. Slide gate on waterward end. (Cat. IVA) FS Date: 10/22/2013

View of waterward side.

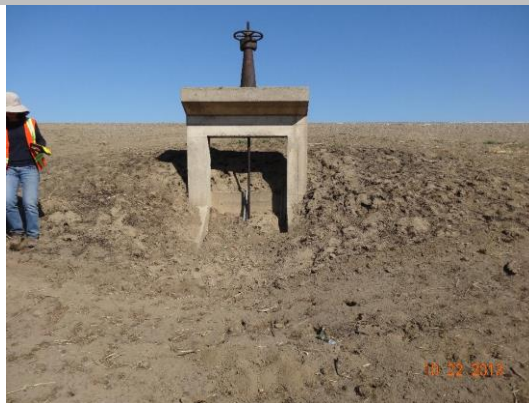
Photo 2 of 3 : UCIP_SP_2017_23892_41841.jpg

Buried screw gate located on waterward shoulder.

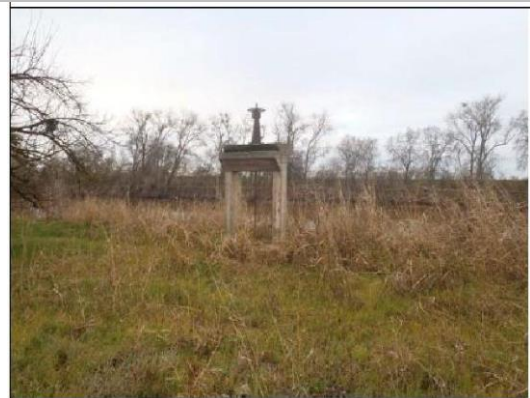
Photo 1 of 2 : UCIP_SP_2017_24115_42495.jpg

LM Start	3.35	Rating **	M	Issue No.	81
LM End	3.35	Issue Type +	En	Location *	LS
Category	Supplemental			GPS Latitude/Longitude	
				Start	End
Item	DWR UCIP Field Study			39.156068 °	39.156068 °
				-121.923453 °	-121.923453 °
DWR ID					
Comment Code					
Inspector Comment					
FS_ID:24115 DS_ID:21370 EP_NO: N/A Repair Type: Non-Urgent Crossing Status: Found UCIP Comments: No connection present--need to contact owner to determine if owner plans to use. If crossing is no longer in use owner will need to coordinate with DWR inspector and CVFPB to remove according to Title 23 requirements. This crossing is referenced in the USACE Periodic Inspection as USACE_CESPK_MRD2_2012_p_0197. FIELD_STRUCT_DESC: *ABANDONED* 24-inch pipe through the levee, 18.5 feet below the crown. Slide gate on concrete gate structure on berm. FS Date: 10/22/2013

View of waterward side--photo is from USACE PI Report draft final issue USACE_CESPK_MRD2_2012_p_0197.

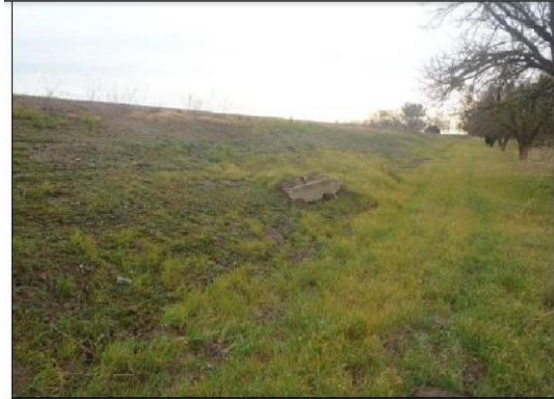
Photo 2 of 2 : UCIP_SP_2017_24115_42496.jpg

LM Start	3.35	Rating **	M	Issue No.	81 (cont)
LM End	3.35	Issue Type +	En	Location *	LS
Category	Supplemental			GPS Latitude/Longitude	
				Start	End
Item	DWR UCIP Field Study			39.156068 °	39.156068 °
				-121.923453 °	-121.923453 °
DWR ID					
Comment Code					
Inspector Comment					
FS_ID:24115 DS_ID:21370 EP_NO: N/A Repair Type: Non-Urgent Crossing Status: Found UCIP Comments: No connection present--need to contact owner to determine if owner plans to use. If crossing is no longer in use owner will need to coordinate with DWR inspector and CVFPB to remove according to Title 23 requirements. This crossing is referenced in the USACE Periodic Inspection as USACE_CESPK_MRD2_2012_p_0197. FIELD_STRUCT_DESC: *ABANDONED* 24-inch pipe through the levee, 18.5 feet below the crown. Slide gate on concrete gate structure on berm. FS Date: 10/22/2013

View of landward side--photo is from USACE PI Report draft final issue
USACE_CESPK_MRD2_2012_p_0197.

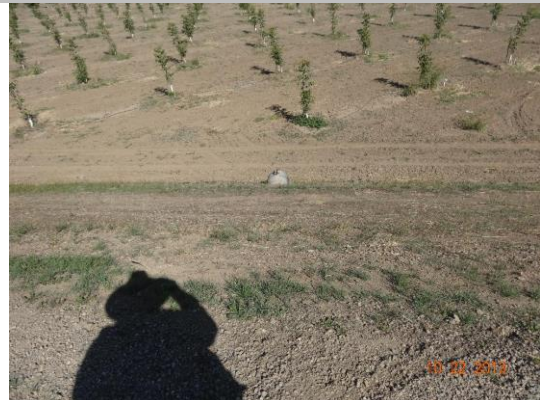
Photo 1 of 2 : UCIP_SP_2017_24117_42502.jpg

LM Start	3.40	Rating **	M	Issue No.	82
LM End	3.40	Issue Type +	En	Location *	LS
Category	Supplemental			GPS Latitude/Longitude	
				Start	End
Item	DWR UCIP Field Study			39.155648 °	39.155648 °
				-121.922823 °	-121.922823 °
DWR ID					
Comment Code					
Inspector Comment					
FS_ID:24117 DS_ID:21371 EP_NO: N/A Repair Type: Non-Urgent Crossing Status: Found UCIP Comments: No connection present--need to contact owner to determine if owner plans to use. If crossing is no longer in use owner will need to coordinate with DWR inspector and CVFPB to remove according to Title 23 requirements. This crossing is referenced in the USACE Periodic Inspection as USACE_CESPK_MRD2_2012_p_0197. FIELD_STRUCT_DESC: *ABANDONED* 24-inch pipe through the levee, 18.5 feet below the crown. Slide gate on concrete gate structure on berm. FS Date: 10/22/2013

View of pipe on landward side.

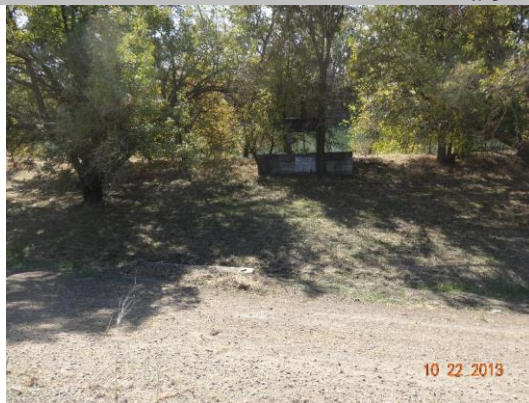
Photo 2 of 2 : UCIP_SP_2017_24117_42501.jpg

Comment Code						
Inspector Comment						
FS_ID:24117						
DS_ID:21371						
EP_NO: N/A						
Repair Type: Non-Urgent						
Crossing Status: Found						
UCIP Comments: No connection present--need to contact owner to determine if owner plans to use. If crossing is no longer in use owner will need to coordinate with DWR inspector and CVFPB to remove according to Title 23 requirements. This crossing is referenced in the USACE Periodic Inspection as USACE_CESPK_MRD2_2012_p_0197.						
FIELD_STRUCT_DESC: *ABANDONED* 24-inch pipe through the levee, 18.5 feet below the crown. Slide gate on concrete gate structure on berm.						
FS Date: 10/22/2013

View of concrete headwall and screw gate on waterward side.

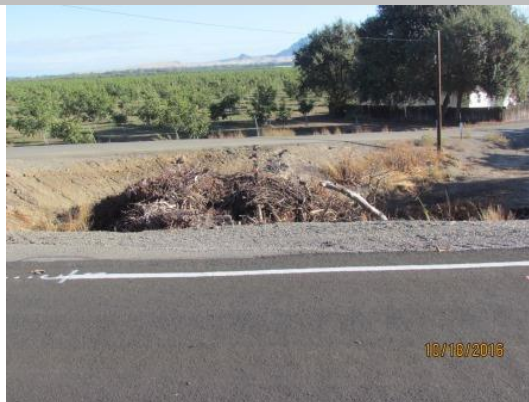
Photo 1 of 1 : SP_2017_RD0070_30_50_20170315_00006.jpg

View of the prunings along the landside toe.

LM Start	3.57	Rating **	M	Issue No.	50
LM End	3.57	Issue Type +	En	Location *	LS
Category	Earthen Levee			GPS Latitude/Longitude	
				Start	End
Item	Encroachments			39.154059 °	39.154059 °
				-121.920220 °	-121.920220 °
DWR ID	DWR_RD0070_02_f_2016_50				
Comment Code					
PR : Prunings					
Inspector Comment					
Remove the prunings from the landside slope.

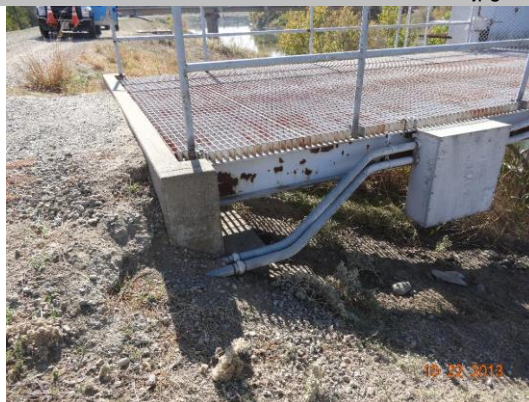
Photo 2 of 3 : UCIP_SP_2017_47030_42567.jpg

Comment Code					
Inspector Comment					
FS_ID:47030 DS_ID:21429 EP_NO: N/A Repair Type: Non-Urgent Crossing Status: Found UCIP Comments: Pump is to be demolished will all pipes removed. Will need to update record. This crossing is referenced in the USACE Periodic Inspection as item USACE_CESPK_MRD2_2012_p_0235. FIELD_STRUCT_DESC: [Farms Water Company Pumping Plant No. 2] 3 of 4: 42-inch steel pipe and 2-inch PVC electrical conduit through the levee, 24.0 and 3.0 feet below the crown, respectively. Pipe is concrete encased through the levee. Two concrete cutoff walls, one at each shoulder. Slide gate in surge box on the waterward side. Concrete pump pit on the waterward slope. Three pumps on structure on the waterward side. Walkway to the pumps with electrical control box. Concrete headwall on landward side. Discharges into concrete lined irrigation ditch on the landward side. Debris deflectors in river. Power poles on landward side. (Permit No. 13380-2002). Pumping plant is to be demolished with all pipes removed and replaced with single 72-inch gravity feed pipe under Permit No. 18762 (2013). FS Date: 10/22/2013

View of conduit pipes through levee.

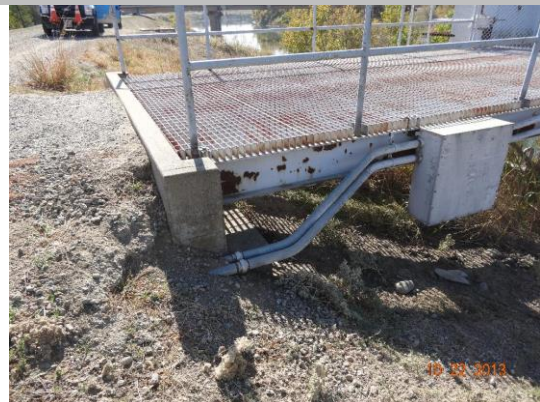
Photo 2 of 3 : UCIP_SP_2017_47032_42080.jpg

FS_ID:47032
DS_ID:21373
EP_NO: N/A
Repair Type: Non-Urgent
Crossing Status: Indicator Found
UCIP Comments: Unable to confirm 54-inch pipe only found 42-inch pipe. Pump station is to be removed. Need to update record once crossing has been modified. This crossing is referenced in the USACE Periodic Inspection as item USACE_CESPK_MRD2_2012_p_0235.
FIELD_STRUCT_DESC: [Farms Water Company Pumping Plant No. 1]
4 of 4: 54-inch steel pipe through the levee, 24.0 feet below the crown. Pipe is concrete encased through the levee. Two concrete cutoff walls, one at each shoulder. Slide gate in surge box on the waterward side. Concrete pump pit on the waterward slope. Three pumps on structure on the waterward side. Walkway to the pumps. Concrete headwall on landward side. Discharges into concrete lined irrigation ditch on the landward side. Debris deflectors in river. (Permit No. 4525-1965). Pumping plant is to be demolished with all pipes removed and replaced with single 72-inch gravity feed pipe under Permit No. 18762 (2013).

View of conduit pipes through levee.

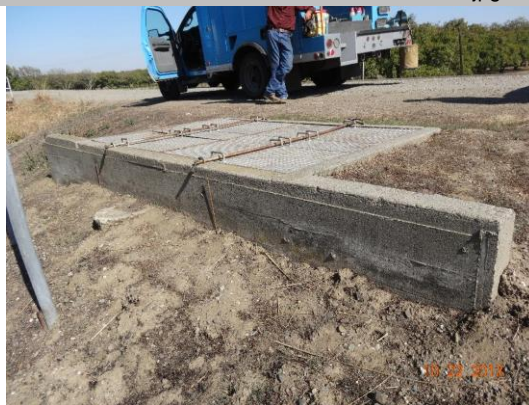
Photo 2 of 3 : UCIP_SP_2017_24165_42575.jpg

FS_ID:24165
DS_ID:21374
EP_NO: 767
Repair Type: Non-Urgent
Crossing Status: Found
UCIP Comments: Need to contact owner to determine if crossing is still active and to determine last inspection date. Will need copy of letter showing crossings passed inspection. This crossing is referenced in the USACE Periodic Inspection as item USACE_CESPK_MRD2_2012_p_0237.
FIELD_STRUCT_DESC: 3.0-inch steel gas pipe (not 3.5-inch as mentioned in desk study) through the levee, 3.0 feet below the crown. Concrete inspection well (8x10x1 foot) with metal cover on waterward shoulder. Painted aluminum marker on waterward side. Rock revetment on waterward slope. (Permit No. 767-1938) Contact information provided on marker 916-742-7344 and for emergencies call 916-742-3251.
FS Date: 10/22/2013

Concrete headwall on waterward side.

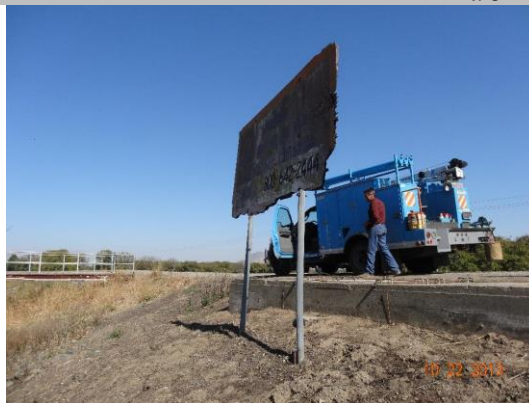
Photo 3 of 3 : UCIP_SP_2017_24165_42576.jpg

Comment Code					
Inspector Comment					
FS_ID:24165 DS_ID:21374 EP_NO: 767 Repair Type: Non-Urgent Crossing Status: Found UCIP Comments: Need to contact owner to determine if crossing is still active and to determine last inspection date. Will need copy of letter showing crossings passed inspection. This crossing is referenced in the USACE Periodic Inspection as item USACE_CESPK_MRD2_2012_p_0237. FIELD_STRUCT_DESC: 3.0-inch steel gas pipe (not 3.5-inch as mentioned in desk study) through the levee, 3.0 feet below the crown. Concrete inspection well (8x10x1 foot) with metal cover on waterward shoulder. Painted aluminum marker on waterward side. Rock revetment on waterward slope. (Permit No. 767-1938) Contact information provided on marker 916-742-7344 and for emergencies call 916-742-3251. FS Date: 10/22/2013

Gas line sign located on waterward side--sign in bad shape.

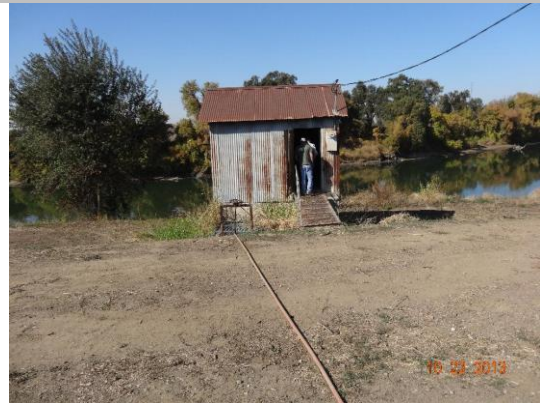
Photo 1 of 3 : UCIP_SP_2017_23962_42099.jpg

Comment Code					
Inspector Comment					
FS_ID:23962 DS_ID:21379 EP_NO: 9998 Repair Type: Non-Urgent Crossing Status: Found UCIP Comments: Unable to confirm if crossing corresponds to permit 9998. Pipe size is different then the pipe size listed in the desk study. Unable to confirm if structure on landward side is a pump house. Need to coordinate with owner to obtain permit record for crossing. Need to verify status of crossing. Permit authorized 24 inch pipe. Pipe through levee is 30 inches. Unable to find stand pipe in field. Dense vegetation limits the inspector's visibility to identify signs of pipe failure (leaks) along the slope. Recommend removing vegetation along pipe alignment to conduct proper inspection of structure and appurtenances. This crossing is referenced in the USACE Periodic Inspection as item USACE_CESPK_MRD2_2012_p_0264. FIELD_STRUCT_DESC: 30-inch (not 24-inch as indicated in desk study) CM pipe through the levee, 15.5 feet below the crown. Slide gate in concrete distribution box at landward toe. Pump in pumphouse at landward side. Service pole and ramp on waterward slope. Concrete box with air vents at waterward end. (USACE-1953). This entry matches the Drainage or Irrigation Structure referenced in O&M manual (Station 516+06). This pipe was retained under ABO No. 9998 (1974). 18-inch PVC pipe sleeved through the 24-inch pipe under Permit No. 16228 (1994). Annular gap grouted. FS Date: 10/22/2013

View of pump house located on waterward side.
